## **Condition Assessment of Building 6237, Old Hospital Complex, Fort Carson, CO**

by Thomas R. Napier and Sheila A. McCarthy

August 2000

ERDC/CERL TR-00-24

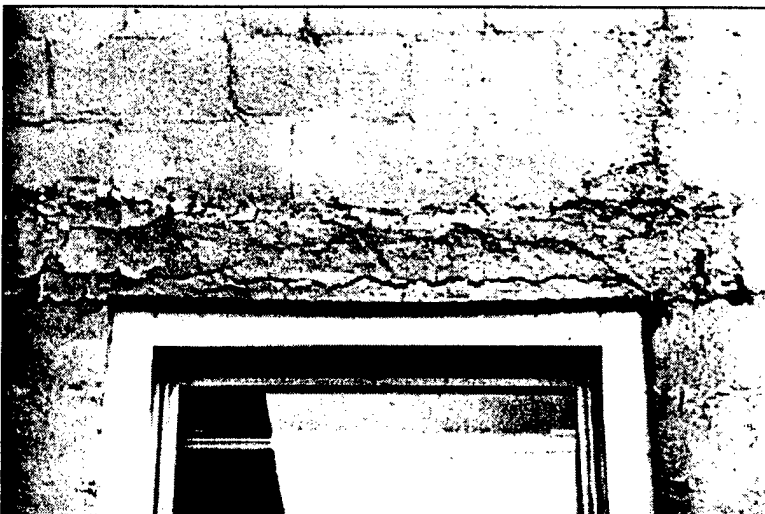
Figure 3-25. First floor lintel.

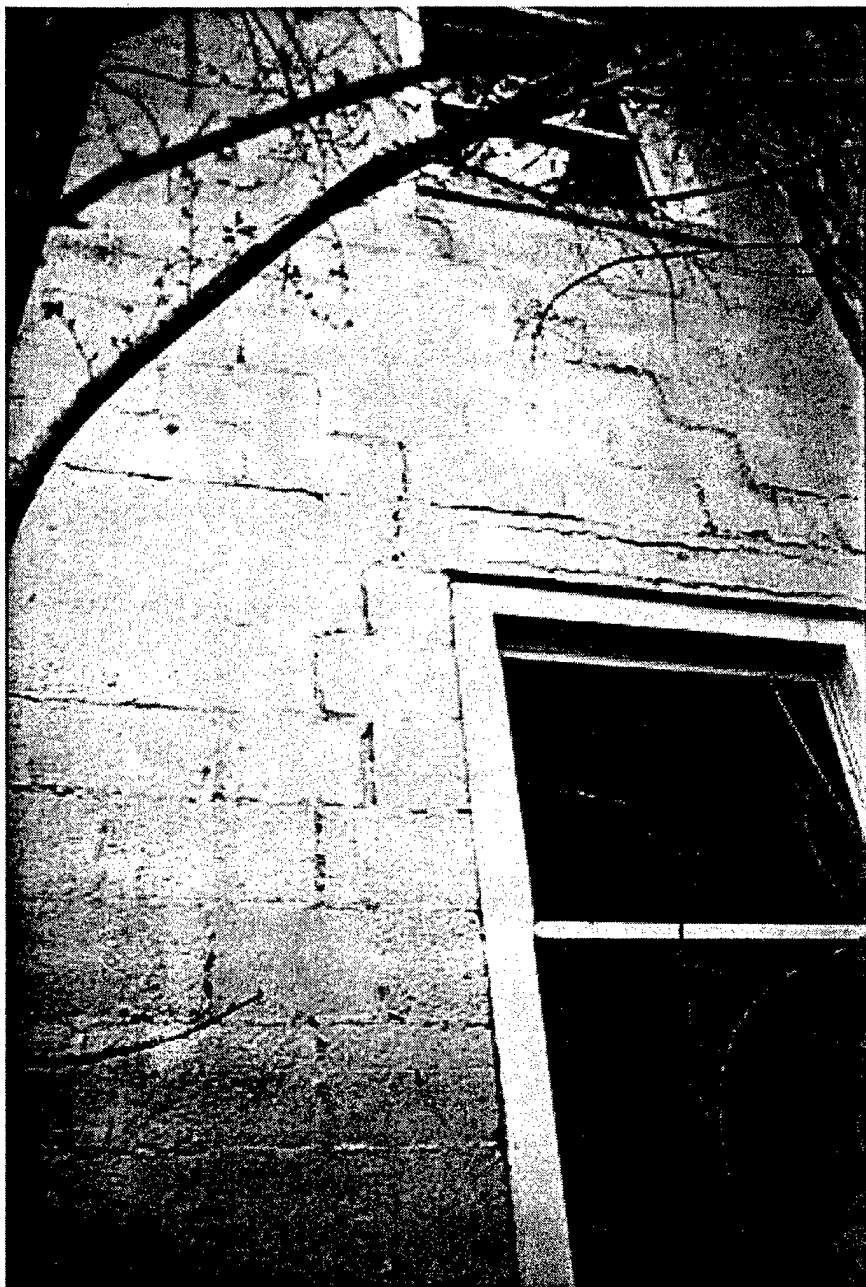
Figure 3-26. Most severe cracking at southeast window.

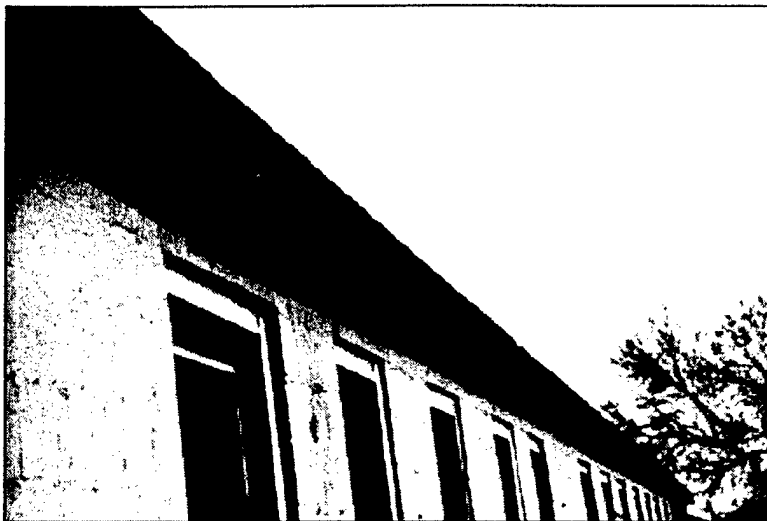
The eave trim appears to be generally intact throughout the main portion of the building. The paint is generally intact. Warping and shrinkage are evident. Warping generally has only opened up gaps in the eave trim (evidenced by daylight visible from the attic spaces), although one fascia board on the west side is severely warped (Point T and Figure 3-30). It is apparent this is caused by the lumber drying out, as opposed to structural movement.

Figure 3-30. Warped fascia board.
